New York State Department of Environmental Conservation

Division of Water

30 Year Trends in Water Quality of Rivers and Streams in New York State

Based on Macroinvertebrate Data 1972 - 2002

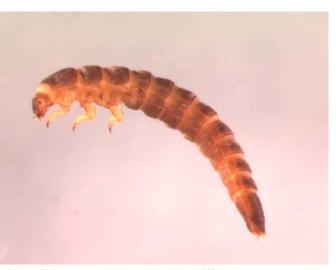
Figure 3-2. The pollution-sensitive riffle beetle *Optioservus*, an indicator of improved water quality, was collected in Eighteenmile Creek at Corwin in 2000.

Water quality at Corwin had been assessed as moderately impacted in 1989 and 1990. In 2000 macroinvertebrate sampling it was assessed as slightly-impacted by municipal/industrial inputs, representing an apparent improvement. The appearance of the pollution-sensitive riffle beetle Optioservus was an indicator of improved water quality. Further sampling is recommended to verify the trend at this site.

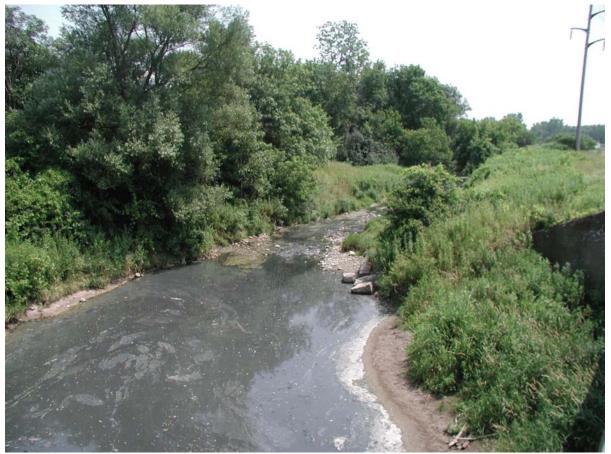
Figure 7-3. Crane Brook near Montezuma, 2002.

Severe impact was documented in Crane Brook near Montezuma in 2002 macroinvertebrate sampling. A potato processing plant discharge was the cause of the impact. Specific conductance at the site was 6979 μ mhos/cm, and dissolved oxygen was 0.8 mg/l. Upstream of this site, water quality was assessed as slightly impacted by nonpoint source nutrient enrichment. This problem is expected to be remediated in the near future.

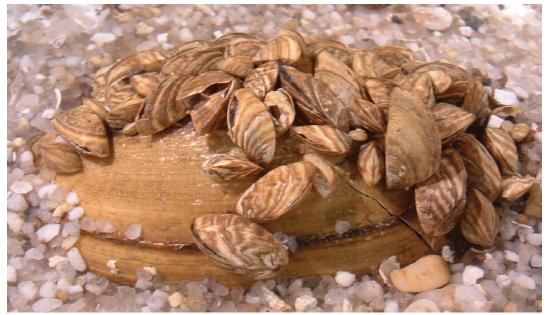
Figure 13-3. Zebra mussels have changed the Hudson River ecosystem.

Zebra mussels were first found in the Hudson River in 1991, and have caused a 57% reduction in the biomass of other benthic animals in the river (Strayer and Smith, 2001).

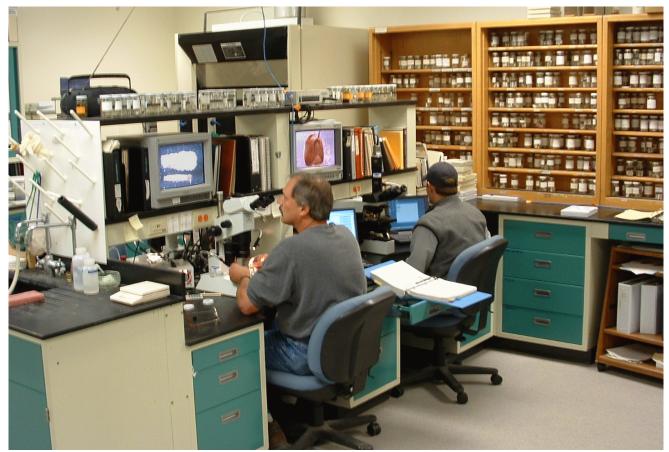
Figure 16-1. Sample processing and organism identification in the Stream Biomonitoring Unit laboratory.
